Manhole Inspection Summary

Manhole # S21K__004MH

Insp Date: **9/26/07 11:23 AM**

Location Address: **1812 PRATT ST**

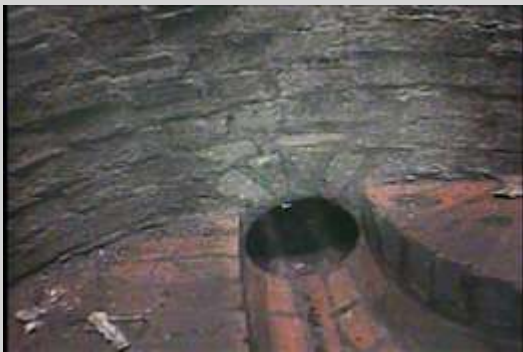
12 O'Clock Outflow

8 in. Circular Gravity Sewer
Pipe Out @ 12 O'Clock

Pipe Height: **8.4** (in.) Rod and Bar (Angled)
Pipe Material: **Clay** ☐ Pipe Lined
Invert Depth: **9.99** (ft.) Flow Characteristics: **Slow**
Deposits: ☒ None ☐ Mud ☐ Sludge ☐ Debris ☐ Grease
Silt Depth: (in.) Deposits Extent:
Infiltration: **None** Pipe Seal Cond: **Sound**

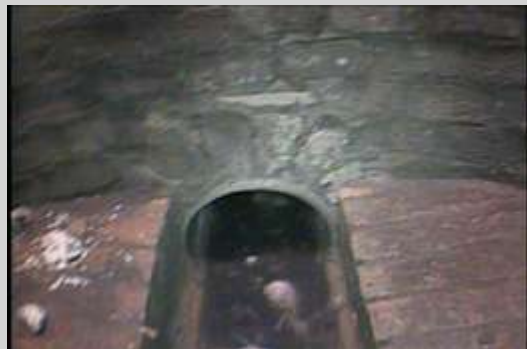
6 O'Clock Inflow

8 in. Circular Gravity Sewer

Pipe In @ 6 O'Clock

Pipe Height: **8.4** (in.) Rod and Bar (Angled)

Infiltration: **None** Pipe Seal Cond: **Sound**
